DEPARTMENT OF TRANSPORTATION

Quality Assurance and Source Inspection

Contract #: 04-0120F4Cty: SF/ALA Rte: 80 PM: 13.2/13.9File #: 69.28**WELDING INSPECTION REPORT****Resident Engineer:**Siegenthaler, Peter**Address:** 333 Burma Road**City:** Oakland, CA 94607**Report No:** WIR-025699**Date Inspected:** 02-Jul-2011**Project Name:** SAS Superstructure**OSM Arrival Time:** 1900**Prime Contractor:** American Bridge/Fluor Enterprises, a JV**OSM Departure Time:** 700**Contractor:** Zhenhua Port Machinery Company, Ltd (ZPMC), Changxing Island **Location:** Shanghai, China**CWI Name:** See below**CWI Present:** Yes No**Inspected CWI report:** Yes No N/A**Rod Oven in Use:** Yes No N/A**Electrode to specification:** Yes No N/A**Weld Procedures Followed:** Yes No N/A**Qualified Welders:** Yes No N/A**Verified Joint Fit-up:** Yes No N/A**Approved Drawings:** Yes No N/A**Approved WPS:** Yes No N/A**Delayed / Cancelled:** Yes No N/A**Bridge No:** 34-0006**Component:** OBG**Summary of Items Observed:**

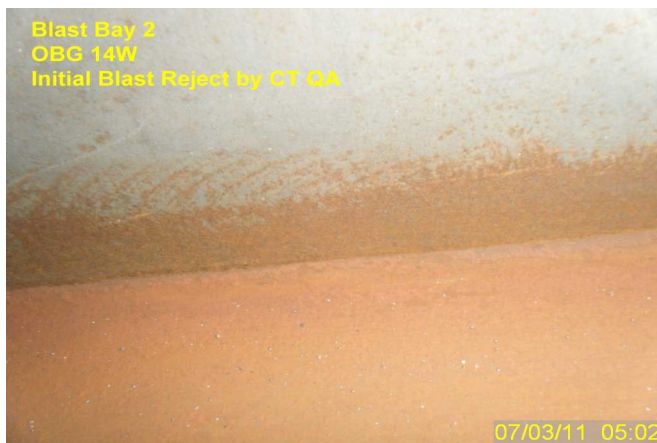
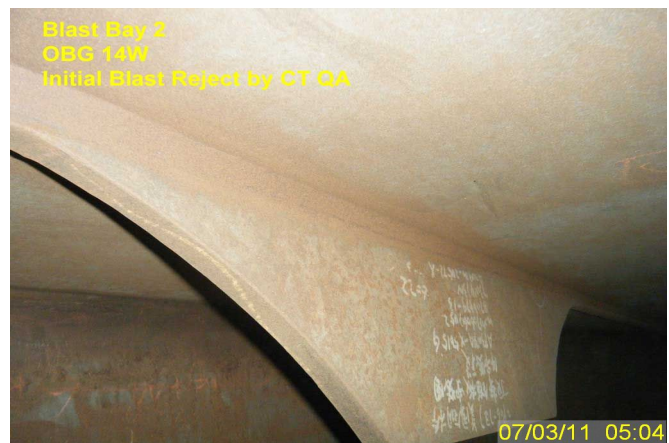
This Caltrans QA Inspector performed a post-blast visual inspection request number 7275, at 5:00, on Lift 14W internal west section ceiling, middle section ceiling and vertical of floor beam from PP125 to OBG end. Surface defects and base metal surface irregularities that required grinding were marked up with colored chalk, and weld defects that require welding were taped with gray masking tape for repair after the coating has been applied. ZPMC QC and ABF inspection personnel were present during the inspection and informed of QA findings. The blast inspection was rejected by Caltrans QA for re-blasting. (see photos below)
